# Pedal Application Error

Apollo Vehicle Safety

## TfL's Vision Zero Strategy

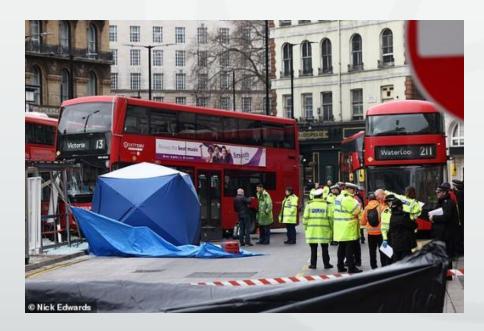
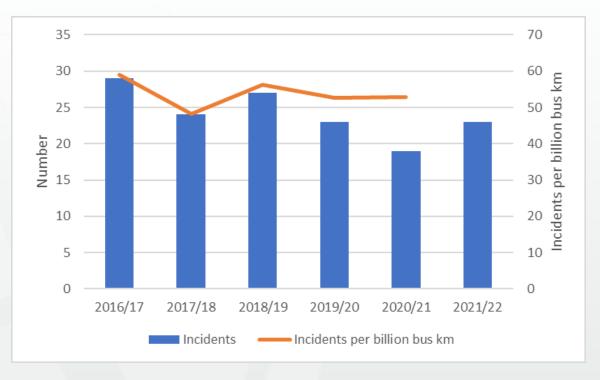
### Quantifying the problem

- Incidents are rare but potentially severe when they do occur.
  - 54 cases/billion bus km, or
  - one event every 18.5 million bus km.

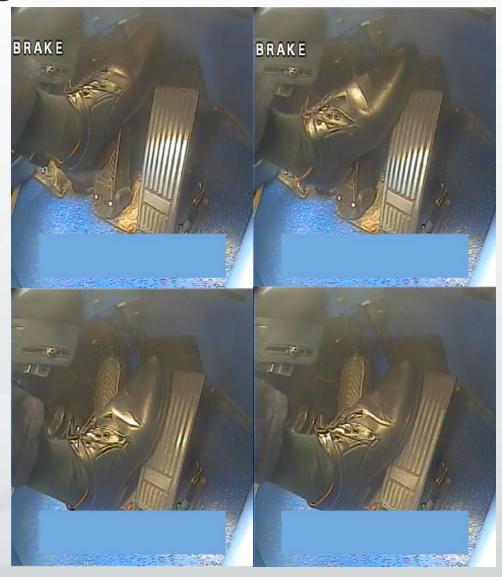
### CCTV footage of normal driving

- CCTV of normal driving
  - Foot movement was variable
  - Most cases "lift & place"

Some evidence of sliding between pedals ----->

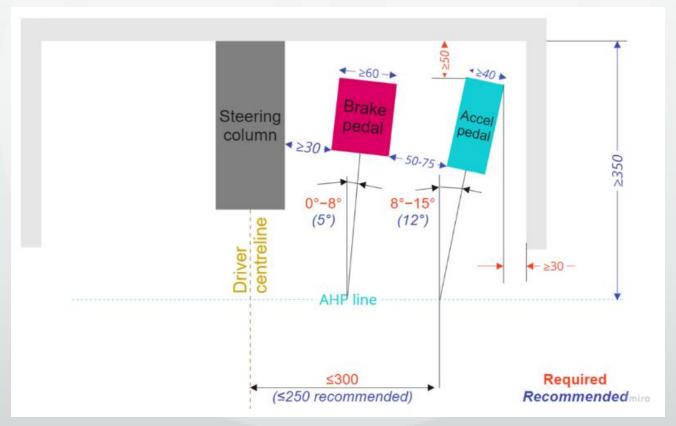
## Pedal layout – ISO 16121

- Defines position and arrangement of pedals
- Not a mandatory standard but bus manufacturers cite this as the basis for their pedal designs

- Some variation in pedal position evident across buses
- Some potential to reduce variation by using recommended values in ISO 16121

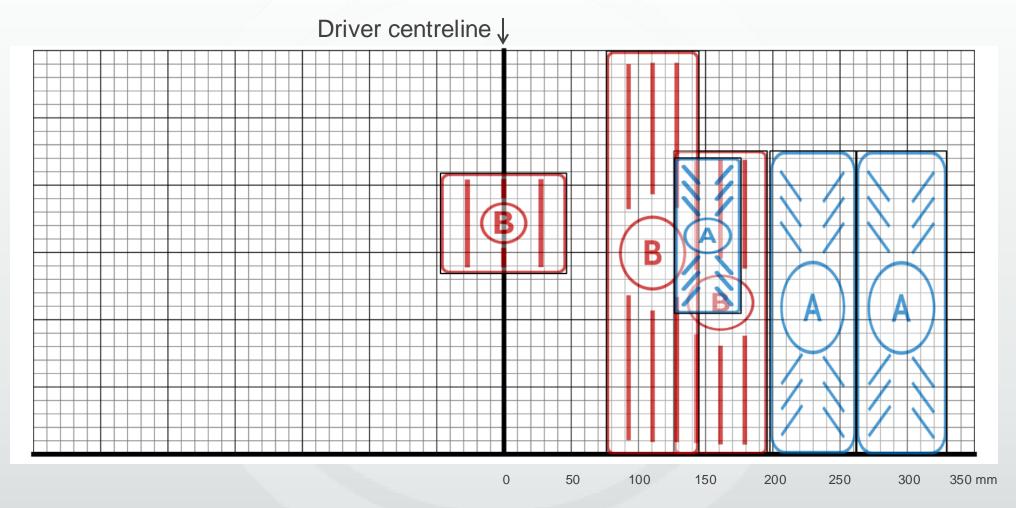
#### Vehicle measurements

Leftmost and rightmost pedals and a typical car layout

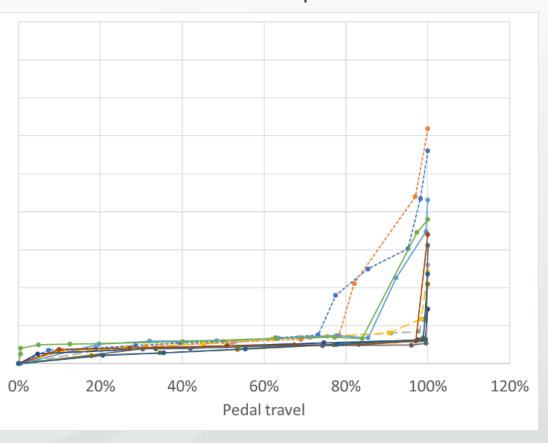
#### Pedal feel

#### Brake pedal 45 40 35 30 Pedal force 25 20 15 10

#### Accelerator pedal

Over 99% of brake applications are very gentle

- Pedals likely feel very similar for the majority of day-to-day driving
- Could improve differentiation by using different pedal types

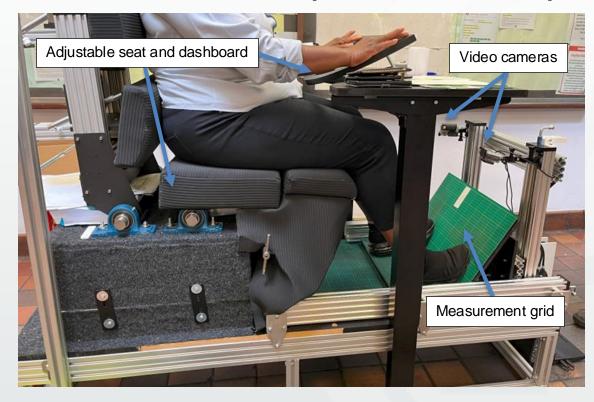
### Driver expectation of pedal position

146 drivers 68 females & 78 males

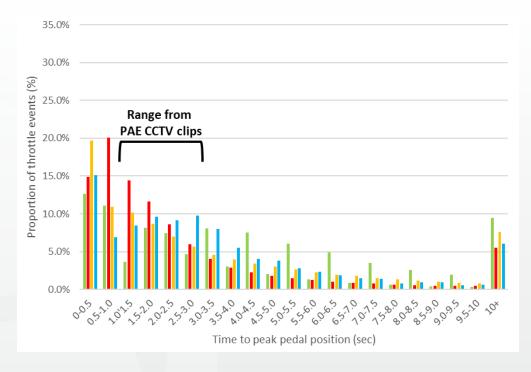
- How best to detect a PAE incident?
- Pedal speed
  - CCTV footage shows relatively slow pedal application
  - Considerable overlap to distribution for normal driving

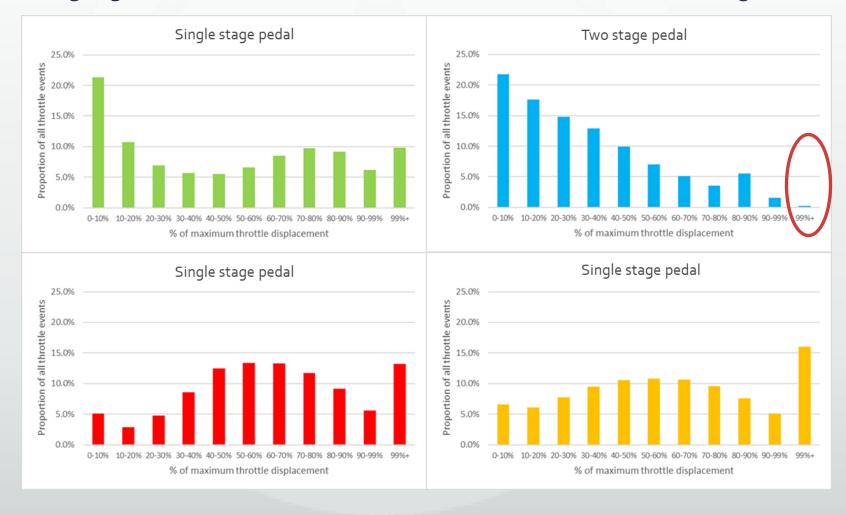
• Pedal data highlighted far fewer full throttle events for buses with two-stage accelerator

pedal

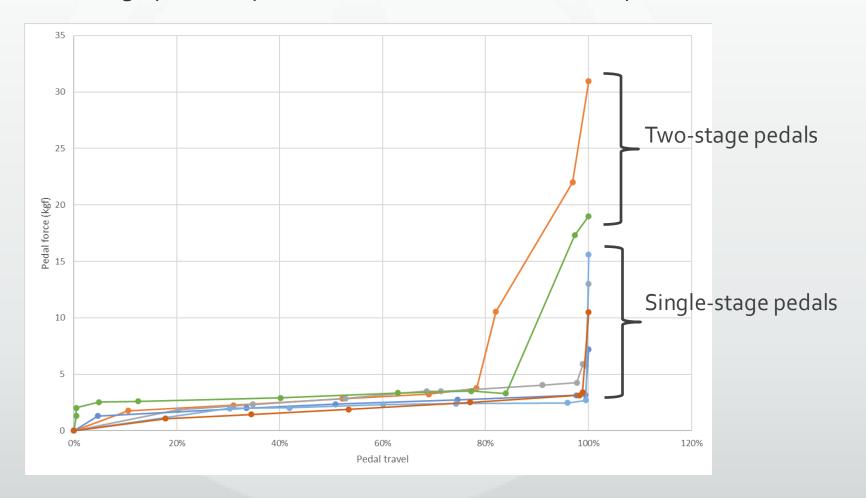
• Buses with two-stage pedal require more force to reach 100% displacement

- If drivers press the accelerator pedal hard during PAE, but rarely press hard during normal driving...
- Can the second stage of the accelerator pedal travel be used to activate an acceleration suppression system and stop prolonged PAE events?
- Initial trial underway to investigate further.
